Hawthorne Meadow Feasibility Study

Appendix B —

Report on existing structural
conditions and structural
capacity prepared by Ryan
Hellwig PE

Re: Hawthorne Meadow Farm
235 East Pleasant Street
Amherst, MA

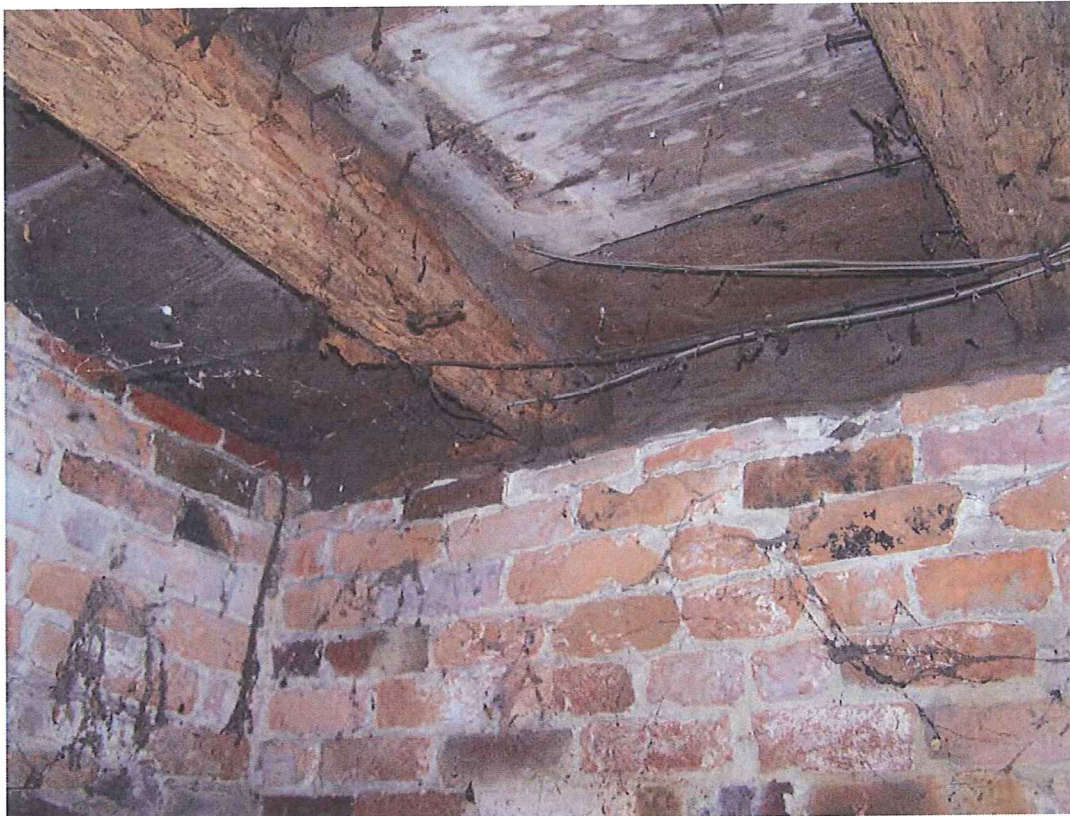
Floor joists and intact sill above brick foundation repair walls

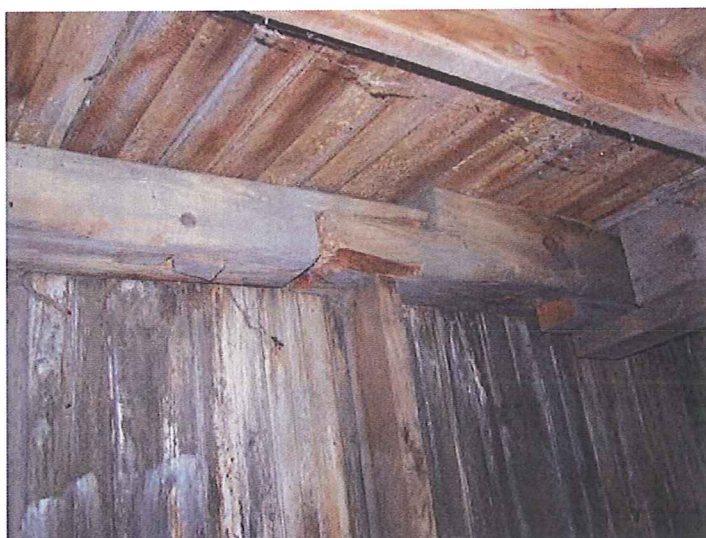
Lapped sill repair in ell section of cellar

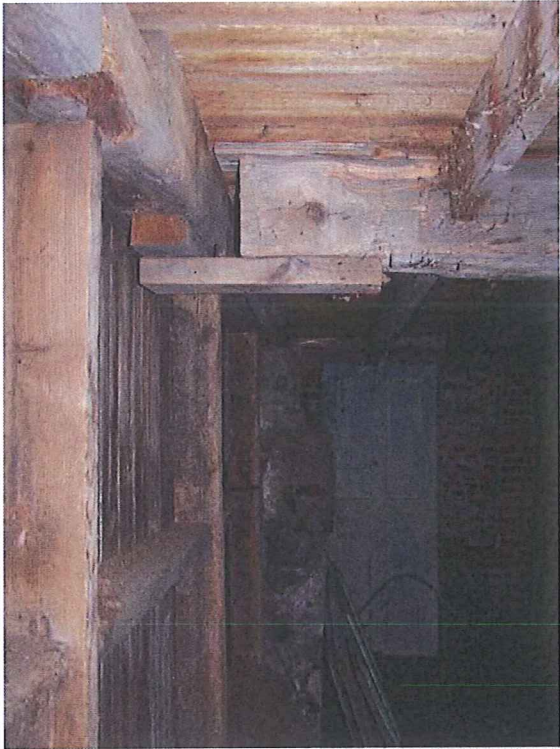
Ell section floor girt with no tenon or mortise held in place by sisters

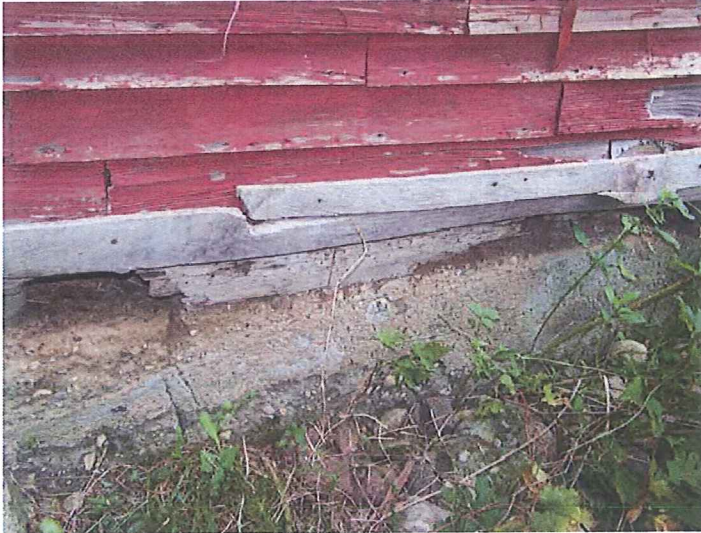
It rests on fieldstone foundations that have tumbled in several places and have had some cement repair work done. The barn was well-built and sided in quarter-sawn clapboards, most of which are probably still original.

Portion of sill on cement above fieldstone

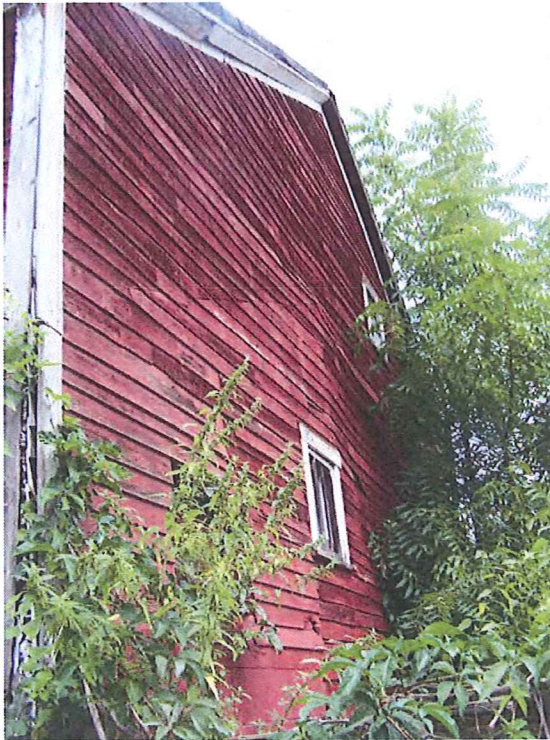
Stud walls are bowing on the barn perhaps due to failing foundations and water penetration from the roof.

East elevation of barn

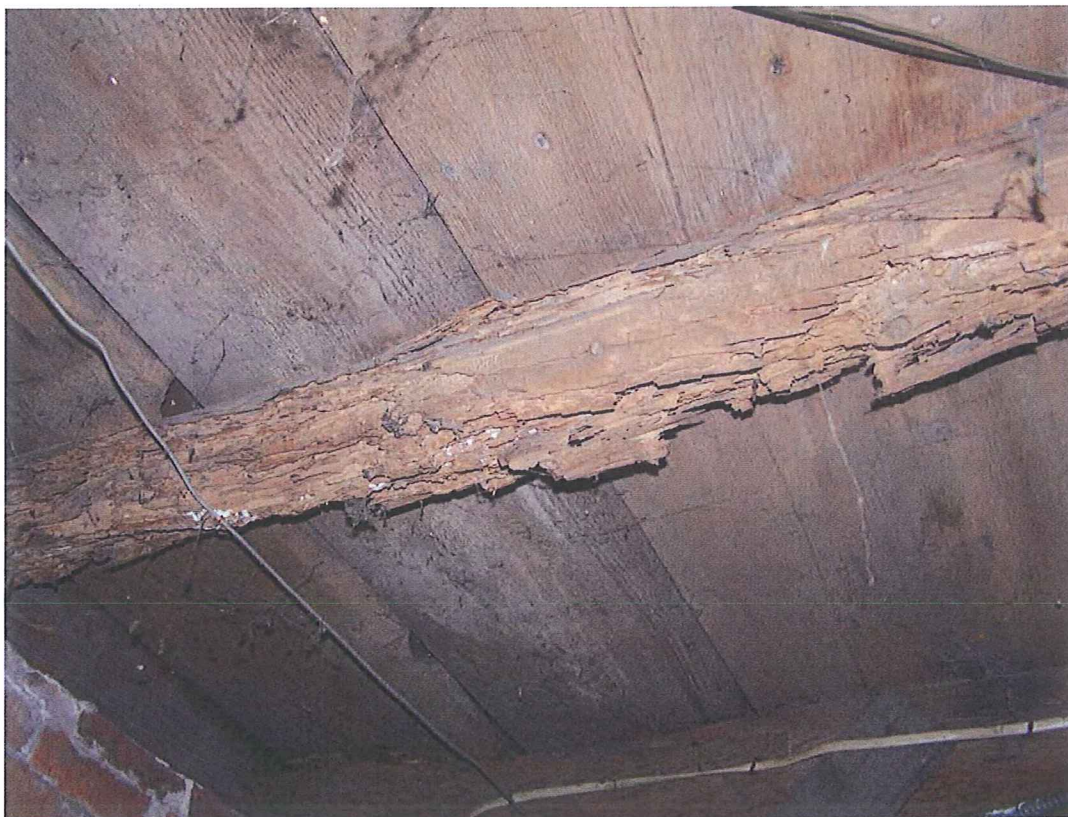
In the cellar beneath the main block of the house, the extent of deterioration of some of the sills and floor joists was underscored. Some of the floor joists appear to have been sawn on all sides. Others were planed only on their top where floor sheathing board were to be laid, sometimes known as "sleepers". The floor joists, girts and sills were tested for moisture and none met the critical 15% point, so the basement is dry. However, the some-time presence of powder post beetles was clearly recognizable on several of the joists and as below, material loss by dry rot.

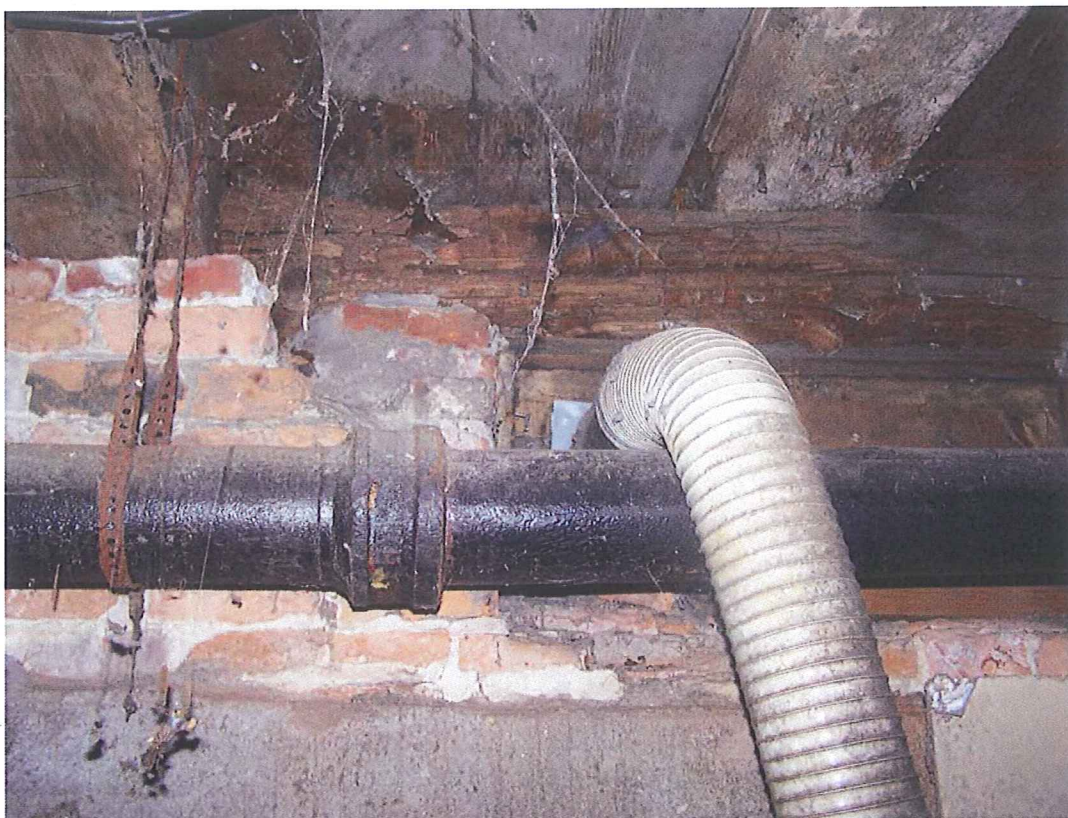
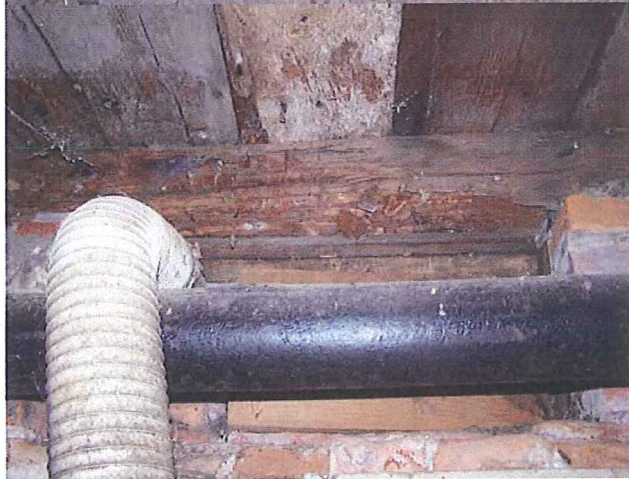
The sill on the north elevation is showing considerable material loss.

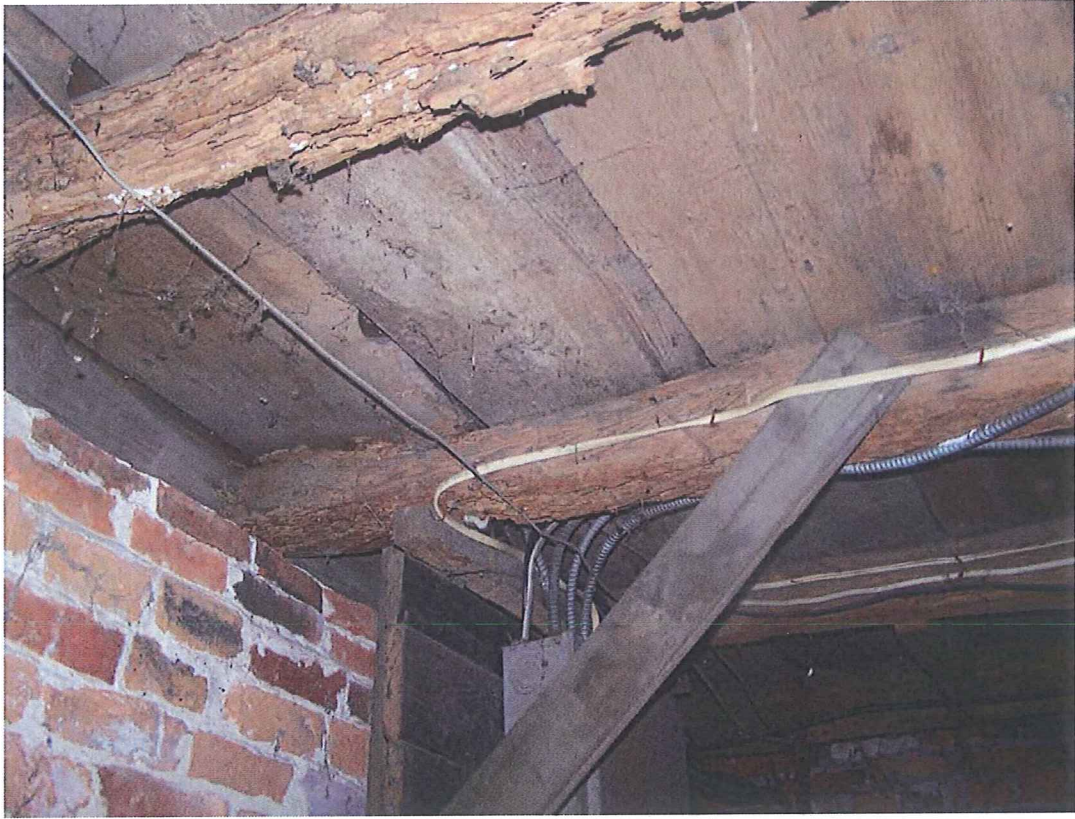
Brick foundations consist of at least two wythes and incorporated fieldstone at their base in the outer layer. The inner layer of brick that is in some places cement-covered, may have been added as a later strengthening effort.

I do not believe that the foundation walls are reliable in their present condition. They should be replaced.

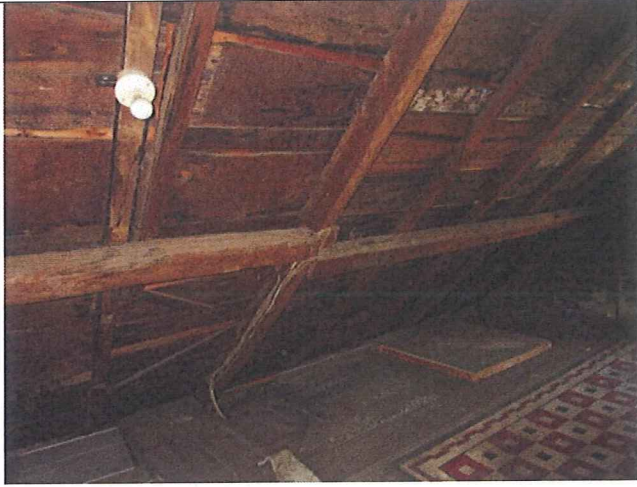
The ends of the purlins have been cut down severely to form tenons that fit into mortises in the principal rafters. This creates a notch effect in the purlins, which weakens the ends. In at least two locations, the grain of the purlins was such that this notching led to a split and shear failure. There is some sag in the roof, more visible from the ground outside.

<p>The existing roof structure — showing the primary rafter supporting purlins to either side, which in turn support the tertiary rafters.</p> <p>All of this original structure can remain exposed in the attic of the renovated building with the retrofit procedure recommended in the study report</p>

1. The foundation and the 1st floor system are in very bad condition and should be completely replaced.
2. The 2nd floor joists and beams are adequate for light residential loads
3. The exterior posts and knee braces appear to be sound
4. A minimum of two interior posts should be installed under the girders.
5. Some reinforcement would be required for the purlins and principal rafters of the roof frame.

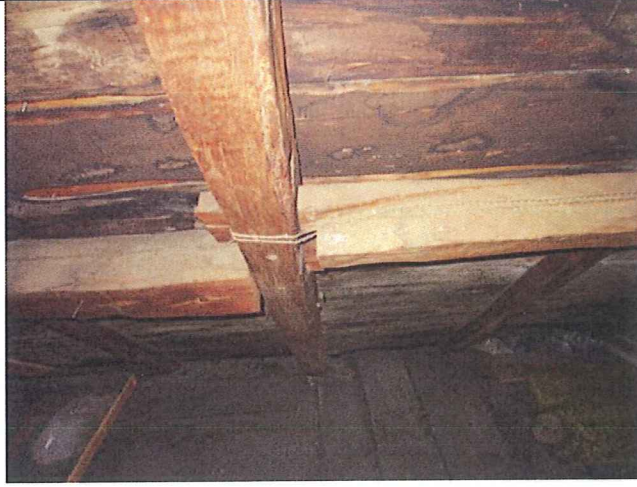
<p>The connection of the purlins to the primary rafter. The purlins are tenoned through mortice holes cut through the center of the primary rafter</p>

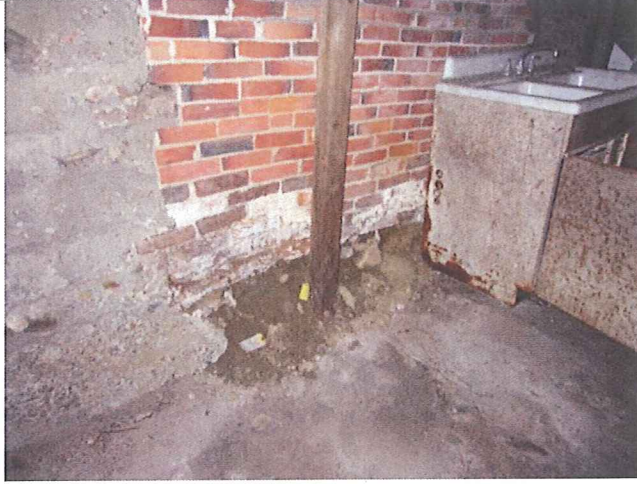
The foundation walls are a mix of brick and granite. It is difficult to tell exactly what is original. There are signs that the basement may have been originally shallower, and may have been dug down at some time in the past. It appears that concrete was poured against the original foundation walls, which may have been a combination of brick and granite slabs. In some areas soils are visible behind that base of the concrete, and in one location the footing seemed to be visible a couple of feet above the floor. The brick walls are bowing and bulging throughout.

<p>The foundation under the existing house. Note the apparent undermining of the brick foundation wall. Note the confusion of brick, concrete, and stone rubble</p>

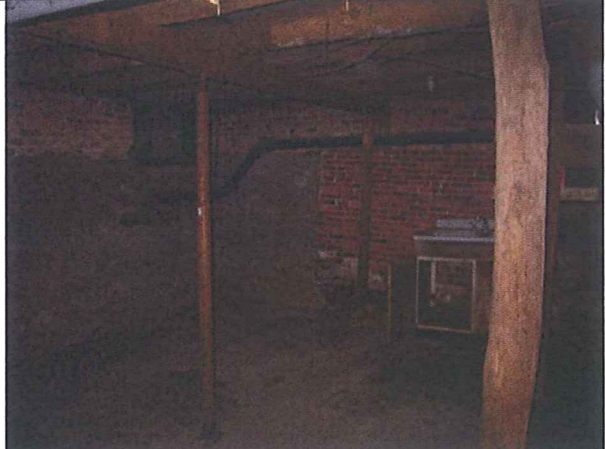
<p>The foundation and first floor structure below the house. Again, note the confusion of brick, concrete, and stone rubble</p>

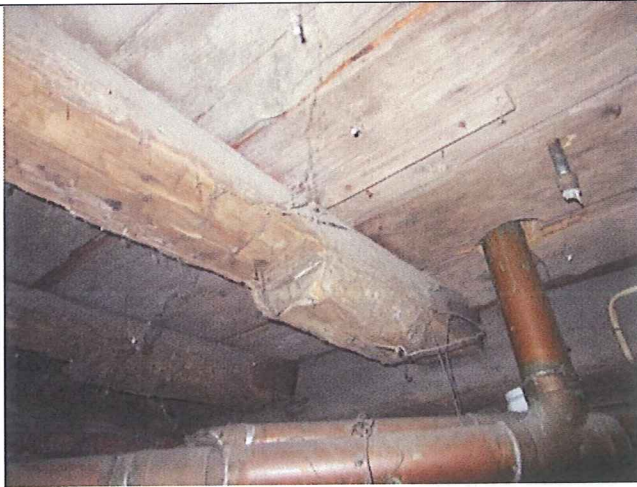
The 1st floor frame is in very poor condition. All of the framing has visible signs of rot. Many locations of the sills are rotten. Some of the joists have been notched severely. The floor dips noticeably in several locations, particularly in the south-west corner, which is presumably due to the rotted sill. There is a general sag towards the center of the house. I believe that this is caused by undersized footings and the mis-alignment between the bay spacing of the attic and 2nd floors relative to the 1st floor. Because the girders span the 21 ft width of the house, they deflect under load and thereby push down on the partition walls which in turn load the first floor joists.

<p>The first floor structural joists that have been severely degraded.</p>

Calculations for the 1st floor frame are not feasible, given the amount of rot. In their original, undamaged state, the joists and beams were fully capable of carrying the loads from the 1st floor. At this point, their capacity is significantly compromised. Between the rot in the sills and the joists and beams, the floor would need to be completely rebuilt. Additional beams and posts are recommended under the walls that support the 2nd floor carrying beams.

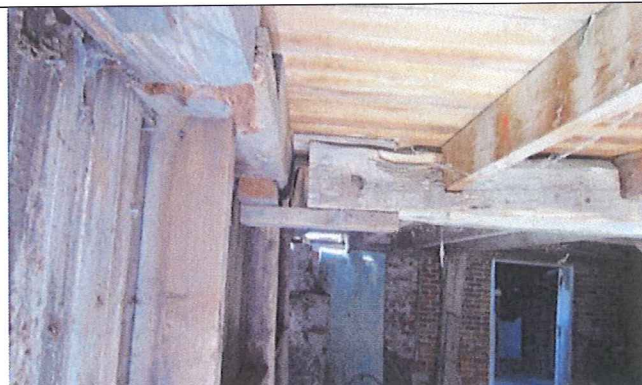
The entire frame of the addition appears to have shifted sideways to the point where joints in the frame have come apart. Old repairs to address this movement are obvious. One section of beam has worked its way completely free of its supports. Overall, the addition settles noticeably towards the east end. This suggests inadequate foundations, so that it is partly hanging off the back of the house. To renovate the addition, most if not all of the structure would need replacement or reinforcement.

<p>The first floor structure below the "Ell". Note that the primary beam does not make it to the post/beam that is supposed to supporting it</p> <p>(Bit of a mystery as to how that porch above is still able to support itself)</p>

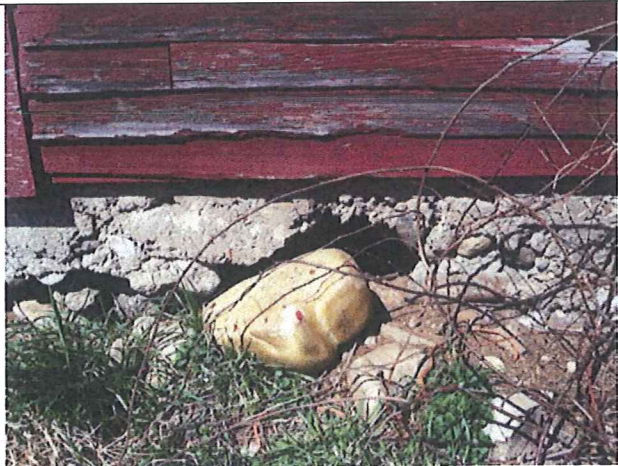
Similarly, the barn is in very poor shape. There are undersized rafters and joists, rotted sills, caved in floors, and undermined rubble foundations.

<p>The barn "foundation wall"</p>

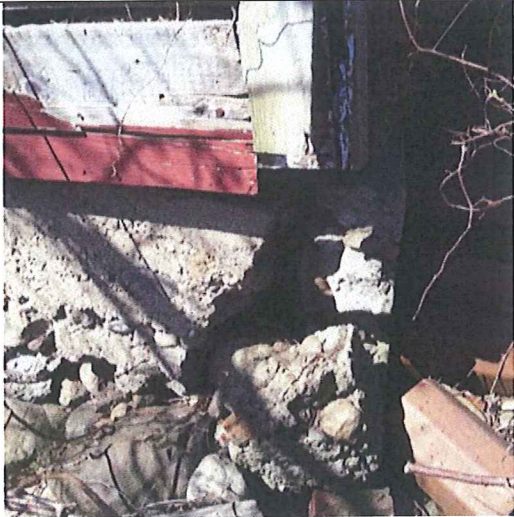
<p>The barn "foundation wall"</p>

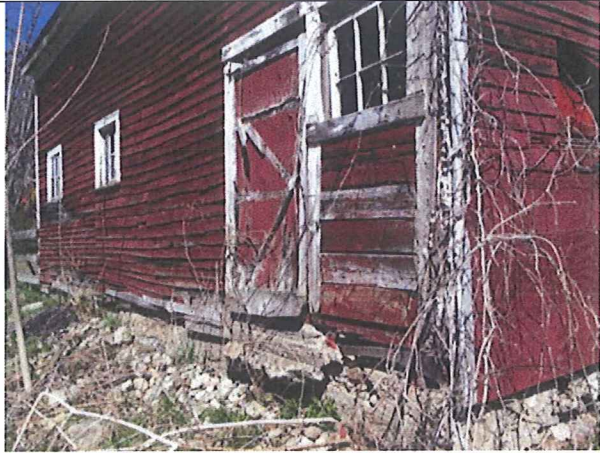
<p>The barn "foundation wall" on the east side.</p>

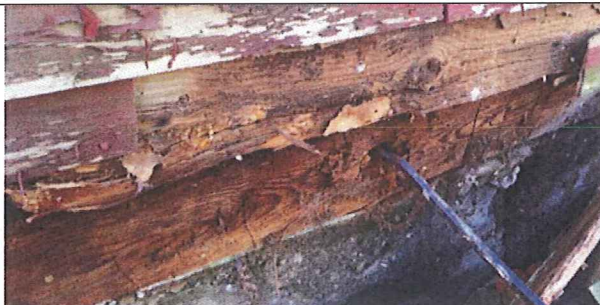
<p>The rotten sill on the north side</p>

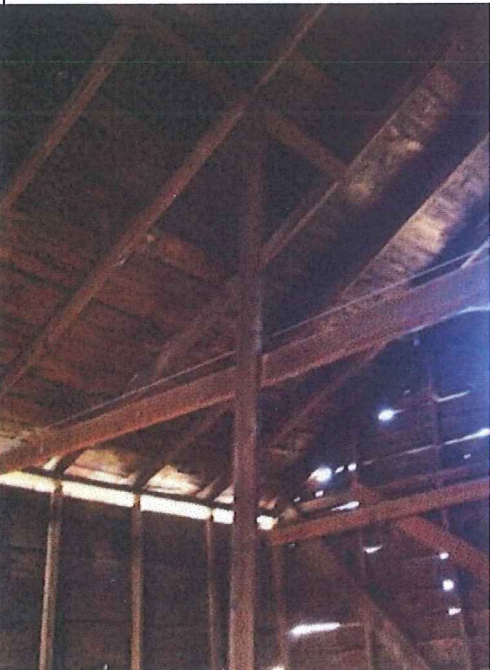
<p>The interior structure of the barn.</p> <p>Note the 2 x 6 central post (one of four) supports a flat board that only picks up some of the rafters.</p> <p>Note the diagonal "bracing" boards on the far side that do not complete any triangulated stiffening pattern</p> <p>Note the extremely wide spacing of the wall studs and rafters</p>
